**Flood Control Project Maintenance  
Levee Inspections**

**Fall 2018 Levee Maintenance Deficiency Summary Report**

**Sacramento River Basin**

**Flood Control Project Maintenance  
Levee Inspections****LMA District Cover Sheet****Fall 2018 Levee Inspection Results****Reclamation District No. 0003 Grand Island**

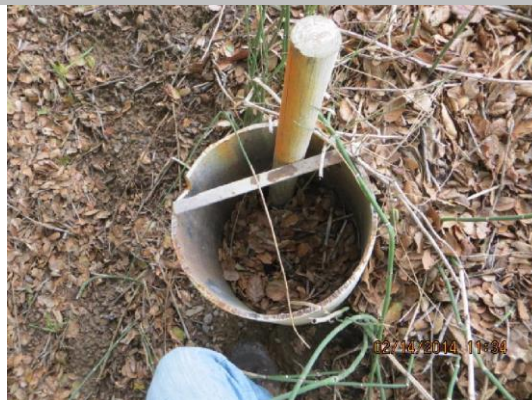
Photo 2 of 3 : UCIP\_FA\_2018\_30083\_55481.jpg

Vent or Siphon Breaker in 14-inch steel riser on LS slope.

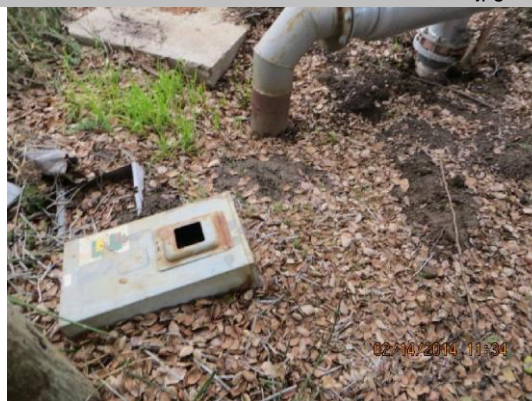
Photo 3 of 3 : UCIP\_FA\_2018\_30083\_55480.jpg

Pipe and filter plant on LS toe.

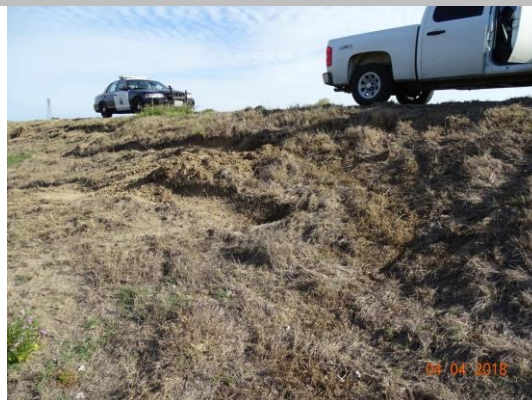
Photo 1 of 1 : FA\_2018\_RD0003\_25\_124\_20180925\_00085.jpg

LM Start	15.94	Rating **	M	Issue No.	124
LM End	15.94	Issue Type +	Ma	Location *	LS
Category	Earthen Levee			GPS Latitude/Longitude	
				Start	End
Item	Slope Stability			38.288009 °	38.288009 °
				-121.558398 °	-121.558398 °
DWR ID	DWR_RD0003_02_s_2018_124				
Comment Code					
S3 : Repair the levee slope damaged by vehicle traffic and prevent access where possible.					
Inspector Comment					
Vehicle erosion on landside slope.

Vehicle erosion on landside slope should be repaired.

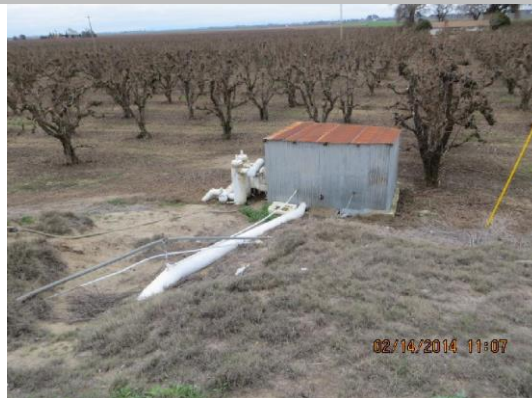
Photo 1 of 3 : UCIP\_FA\_2018\_30004\_55382.jpg

Pump in pumphouse on LS toe.

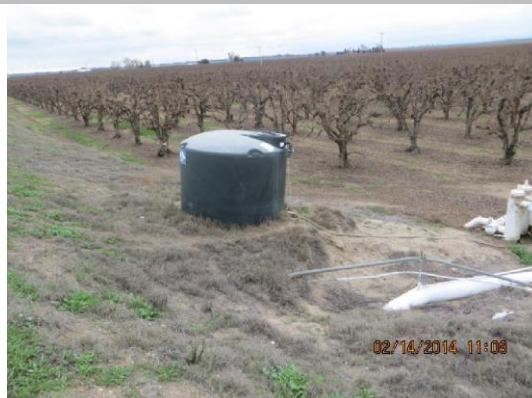
Photo 2 of 3 : UCIP\_FA\_2018\_30004\_55381.jpg

Comment Code					
Inspector Comment					
FS_ID:30004 DS_ID:22376 EP_NO: 17382 Repair Type: Non-Urgent Crossing Status: Found UCIP Comments: Tank on LS slope not listed in permit. FIELD_STRUCT_DESC: 12-inch steel irrigation discharge pipe through the levee, 10 feet below the crown. Pump and butterfly valve in a pump house at the landside (LS) toe. Siphon breaker on the waterside (WS) slope. Tank on the LS slope. (Plans to abandon in place two existing deteriorated pipes and install a 12-inch steel irrigation pipe and a 2-inch steel irrigation pipe through the crown and on the slopes of the levee authorized under Permit No. 17382, 2001 - Ferreira Estate Company, DCC Engineering Company, Inc). [Additional Reference(s): DWR Levee Log, 1993, referenced as 5.2 feet below the crown]. FS Date: 2/14/2014

Tank on LS slope not noted in permit.

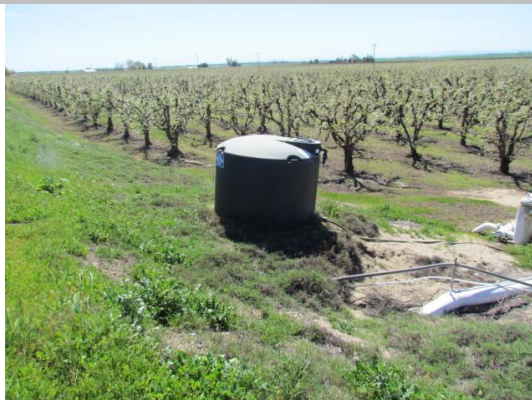
Photo 2 of 2 : FA\_2018\_RD0003\_25\_75\_20180925\_00054.jpg

LM Start	16.04	Rating **	M	Issue No.	75 (cont)	
LM End	16.04	Issue Type +	En	Location *	LS	
Category	Earthen Levee			GPS Latitude/Longitude		
				Start		End
Item	Encroachments			38.289126°		38.289126°
				-121.559631°		-121.559631°
DWR ID	DWR_RD0003_02_s_2014_75					
Comment Code						
TA : Tank						
Inspector Comment						
Tank is located next to irrigation system on landside slope. No permit for this tank was found.

Looking southwest at tank on landside slope.

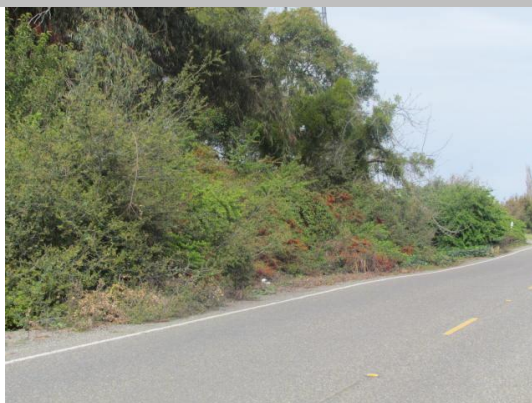
Photo 1 of 1 : FA\_2018\_RD0003\_25\_60\_20180925\_00045.jpg

LM Start	16.20	Rating **	U	Issue No.	60
LM End	16.25	Issue Type +	En	Location *	LS
Category	Earthen Levee			GPS Latitude/Longitude	
				Start	End
Item	Vegetation			38.290742 °	38.291390 °
				-121.561575 °	-121.562268 °
DWR ID	DWR_RD0003_02_s_2012_60				
Comment Code					
V6 : Landscaping					
Inspector Comment

Looking west at dense landscaping on landside shoulder and slope.

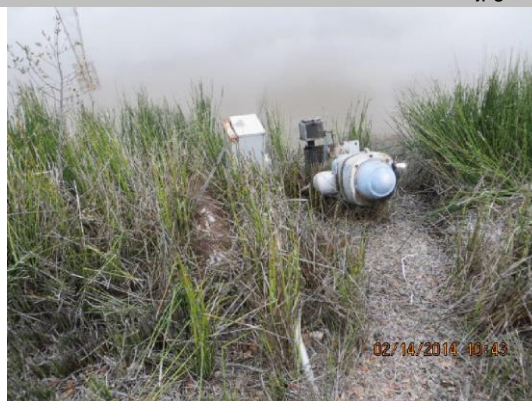
Photo 1 of 3 : UCIP\_FA\_2018\_29986\_55369.jpg

Slant pump and electrical conduit on WS slope.

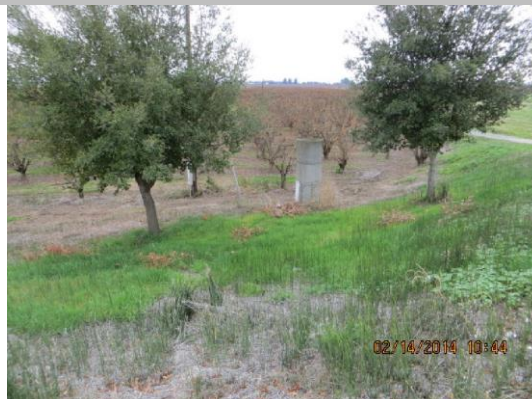
Photo 2 of 3 : UCIP\_FA\_2018\_29986\_55368.jpg

44-inch concrete standpipe on LS toe.

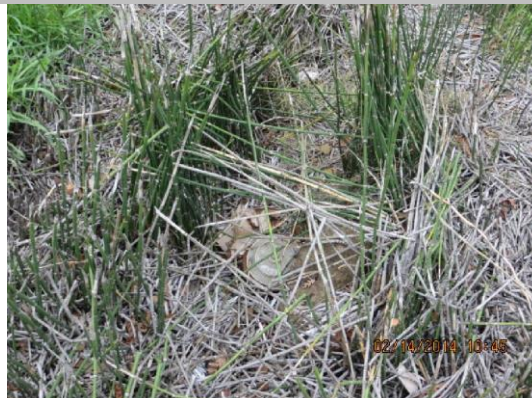
Photo 3 of 3 : UCIP\_FA\_2018\_29986\_55367.jpg

Item	DWR UCIP Field Study			38.292413 °	38.292413 °	
				-121.563301 °	-121.563301 °	
DWR ID	22378					
Comment Code						
Inspector Comment						
FS_ID:29986 DS_ID:22378 EP_NO: N/A Repair Type: Non-Urgent Crossing Status: Found UCIP Comments: siphon breaker on LS slope should have CMP riser protection. FIELD_STRUCT_DESC: 16-inch steel irrigation discharge pipe through the levee, 8 feet below the crown. Slant pump on the waterside (WS) slope. Siphon breaker on the landside (LS) slope. 44-inch concrete standpipe at the LS toe. 2-inch aluminum electrical conduit through the levee at the same location as the pipe. (T. Ferreira. USACE Unit No. 6, 1967). [Additional Reference(s): DWR Levee Log, 1993, referenced as 15 feet below the crown. USACE Sacramento O&M Manual 104, February 1960, (RM 31.39), 12-inch pipe, invert elevation 15 feet below the crown, referenced]. FS Date: 2/14/2014

Siphon breaker on LS slope

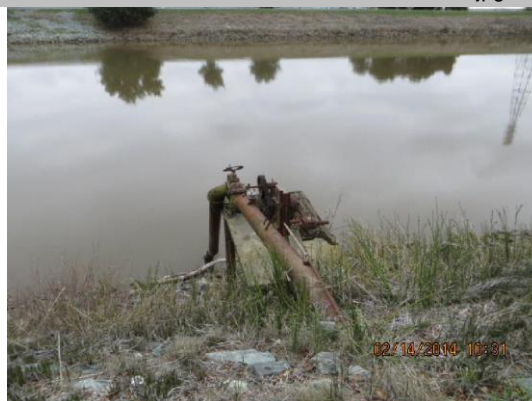
Photo 1 of 3 : UCIP\_FA\_2018\_53487\_55362.jpg

FS\_ID:53487  
DS\_ID:22380  
EP\_NO: 1075  
Repair Type: Urgent  
Crossing Status: Found  
UCIP Comments: 07/20/2018 Sinkhole is still visible on the crown roadway, but it hasn't appeared to have gotten any deeper. Sinkhole on the LS slope has been repaired. No pipe replacement has been made yet. Need to determine the pipe condition through the levee. Crossing remains "Urgent" due to signs of integrity issues. (A. McDonald - DWR UCIP)07/06/2016 Same as last inspection. Pipe to be replaced soon via CVFPB permit. (DWR UCIP - kfazel)02/14/2014 Apparent sinkhole over pipe at crown. Appears abandoned and should be done so properly. (DWR UCIP - pamatya)  
FIELD\_STRUCT\_DESC: \*ABANDONED\* 10-inch (not 12-inch as mentioned in the desk study) steel irrigation discharge pipe through the levee, invert elevation 3.7 feet below the crown. Pump and gate valve on a pier on the waterside (WS) slope. 44-inch concrete standpipe at the landside (LS) toe. 1.5-inch electrical conduit through the levee at the same location. (Plans for installation of a pumping plant with a 12-inch discharge line through the levee authorized under Permit No. 1075, 1945 - R. B. Kercheval). Robert Kercheval, lindakerch@gmail.com, (916) 429-8005, with DCC Engineering Company, Inc, has applied for a replacement CVFPB permit. Contact: Emily Pappalardo, emily@dccengineering.net. [Additional Reference(s): DWR Levee Log, 1993, 12-inch pipe referenced. USACE Sacramento O&M Manual 104, February 1960, (RM 31.52), 8-inch pipe referenced].

Pipe and pump on concrete pad on WS slope.

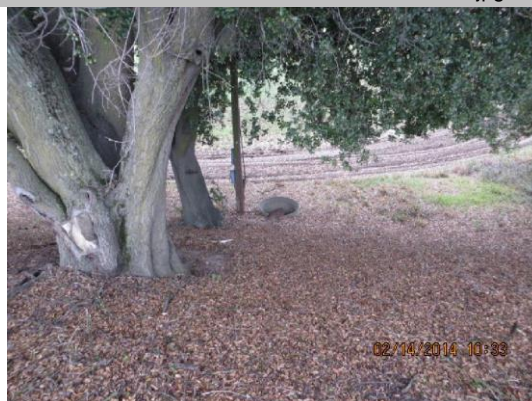
Photo 3 of 3 : UCIP\_FA\_2018\_53487\_55360.jpg

UCIP Comments: 07/20/2018 Sinkhole is still visible on the crown roadway, but it hasn't appeared to have gotten any deeper. Sinkhole on the LS slope has been repaired. No pipe replacement has been made yet. Need to determine the pipe condition through the levee. Crossing remains "Urgent" due to signs of integrity issues. (A. McDonald - DWR UCIP)07/06/2016 Same as last inspection. Pipe to be replaced soon via CVFPB permit. (DWR UCIP - kfazel)02/14/2014 Apparent sinkhole over pipe at crown. Appears abandoned and should be done so properly. (DWR UCIP - pamatya)

FIELD\_STRUCT\_DESC: \*ABANDONED\* 10-inch (not 12-inch as mentioned in the desk study) steel irrigation discharge pipe through the levee, invert elevation 3.7 feet below the crown. Pump and gate valve on a pier on the waterside (WS) slope. 44-inch concrete standpipe at the landside (LS) toe. 1.5-inch electrical conduit through the levee at the same location. (Plans for installation of a pumping plant with a 12-inch discharge line through the levee authorized under Permit No. 1075, 1945 - R. B. Kercheval). Robert Kercheval, lindakerch@gmail.com, (916) 429-8005, with DCC Engineering Company, Inc, has applied for a replacement CVFPB permit. Contact: Emily Pappalardo, emily@dccengineering.net. [Additional Reference(s): DWR Levee Log, 1993, 12-inch pipe referenced. USACE Sacramento O&M Manual 104, February 1960, (RM 31.52), 8-inch pipe referenced].  
FS Date: 7/20/2018

Concrete standpipe and meter on pole at LS toe.

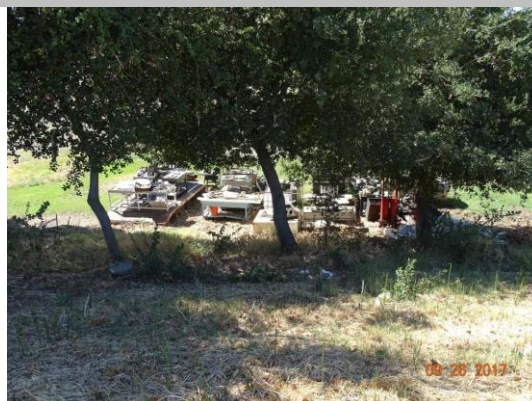
Photo 1 of 2 : FA\_2018\_RD0003\_25\_166\_20180925\_00139.jpg

LM Start	16.54	Rating **	M	Issue No.	166
LM End	16.54	Issue Type +	En	Location *	LS
Category	Earthen Levee			GPS Latitude/Longitude	
				Start	End
Item	Encroachments			38.294600 °	38.294600 °
				-121.565592 °	-121.565592 °
DWR ID	DWR_RD0003_02_f_2017_166				
Comment Code					
EQ : Equipment					
Inspector Comment					
Landowner has equipment and wood stored at toe of landside slope.

Looking southwest at the landside slope.

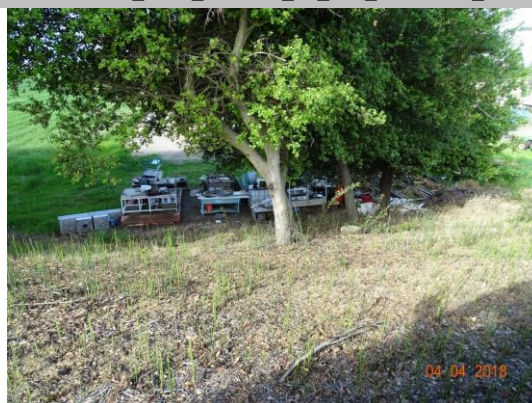
Photo 2 of 2 : FA\_2018\_RD0003\_25\_166\_20180925\_00140.jpg

Equipment at landside toe.

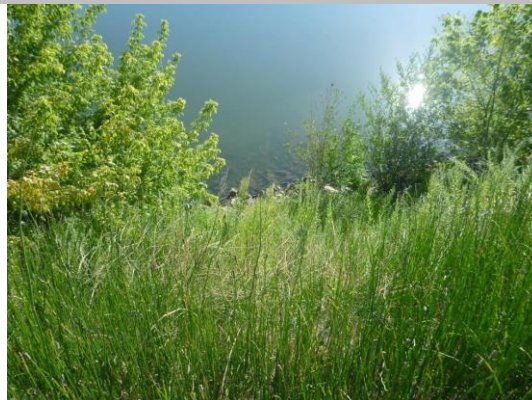
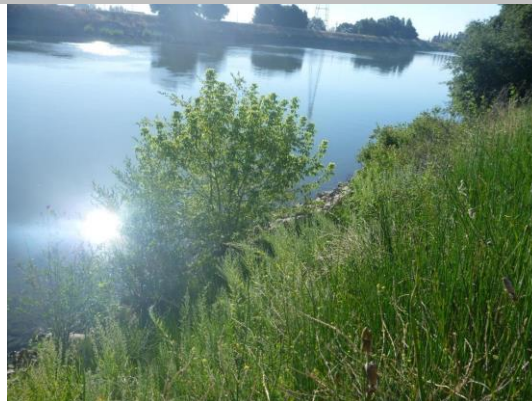
LM Start	16.54	Rating **	A/W	Issue No.	150
LM End	16.56	Issue Type +	Ma	Location *	
Category	Supplemental			GPS Latitude/Longitude	
				Start	End
Item	2017 Storm Damage			38.294717 °	38.294986 °
				-121.565417 °	-121.565661 °
DWR ID	DWR_RD0003_02_f_2017_150				
Comment Code					
Inspector Comment					
Levee Evaluation Comments					
Description:District station 873+61 to 874+83, Sec. 08, T. 5 N. R. 4 E., M.D.M. Approximately 122 linear feet of erosion exists along the water side slope of the Sacramento River (Unit 2). The erosion commences approximately 1/2 of the way down the slope from the crown and extends beyond the rip rap. A section of rip rap has eroded away in this location.					
Site ID No:284					
Site Designation:LMA-110					
Repair Type: Erosion					
Rating:Area of Concern					
Field Date:7/28/2017					
Notes: no berm

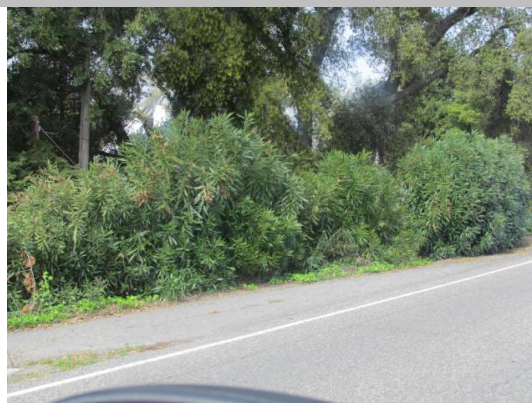
Photo 1 of 4 : FA\_2018\_RD0003\_25\_77\_20180925\_00057.jpg

LM Start	16.58	Rating **	M	Issue No.	77
LM End	16.60	Issue Type +	En	Location *	LS
Category	Earthen Levee			GPS Latitude/Longitude	
				Start	End
Item	Vegetation			38.295082 °	38.295395 °
				-121.566037 °	-121.566232 °
DWR ID	DWR_RD0003_02_s_2012_77				
Comment Code					
V6 : Landscaping					
Inspector Comment					
Landowner removed oleanders, but other vegetation still blocking view of landside slope and toe.

Looking west at landscaping on landside shoulder and slope. (Fall 2015)

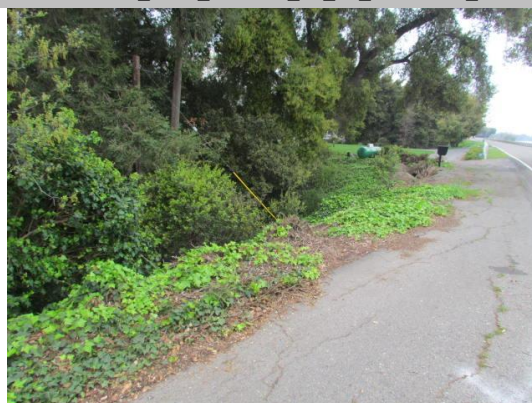
Photo 2 of 4 : FA\_2018\_RD0003\_25\_77\_20180925\_00058.jpg

Looking north at landscape on landward slope and toe. (Spring 2016)

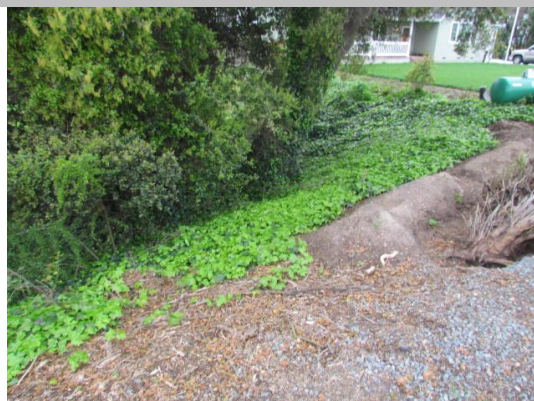
Photo 3 of 4 : FA\_2018\_RD0003\_25\_77\_20180925\_00059.jpg

LM Start	16.58	Rating **	M	Issue No.	77 (cont)	
LM End	16.60	Issue Type +	En	Location *	LS	
Category	Earthen Levee			GPS Latitude/Longitude		
				Start	End	
Item	Vegetation			38.295082 °	38.295395 °	
				-121.566037 °	-121.566232 °	
DWR ID	DWR_RD0003_02_s_2012_77					
Comment Code						
V6 : Landscaping						
Inspector Comment						
Landowner removed oleanders, but other vegetation still blocking view of landside slope and toe.

Looking north at landscape on landward slope and toe. (Spring 2016)

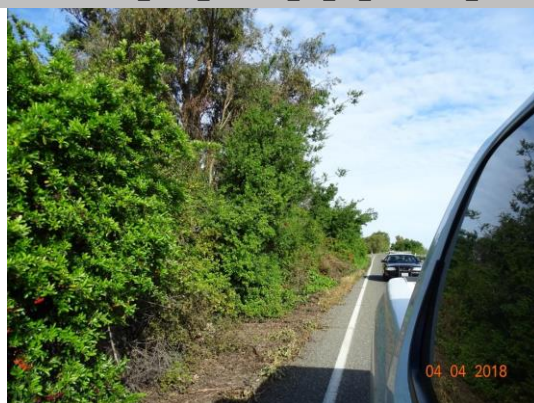
Photo 4 of 4 : FA\_2018\_RD0003\_25\_77\_20180925\_00060.jpg

LM Start	<b>16.58</b>	Rating **	M	Issue No.	<b>77 (cont)</b>
LM End	<b>16.60</b>	Issue Type +	En	Location *	LS

Dense landside landscaping.

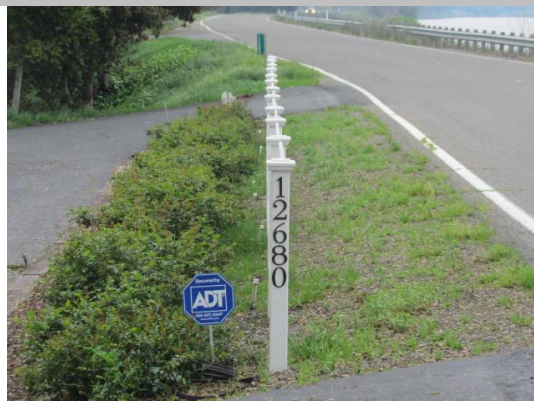
Photo 1 of 2 : FA\_2018\_RD0003\_25\_146\_20180925\_00118.jpg

LM Start	16.60	Rating **	M	Issue No.	146
LM End	16.60	Issue Type +	En	Location *	LS
Category	Earthen Levee			GPS Latitude/Longitude	
				Start	End
Item	Encroachments			38.295263 °	38.295263 °
				-121.566193 °	-121.566193 °
DWR ID	DWR_RD0003_02_s_2016_146				
Comment Code					
FE : Fence					
Inspector Comment					
Landowner install white fence on landside shoulder. No permit identified for fence.

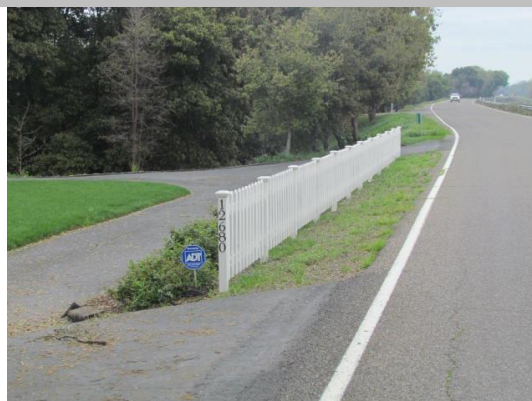
Photo 2 of 2 : FA\_2018\_RD0003\_25\_146\_20180925\_00119.jpg

LM Start	16.60	Rating **	M	Issue No.	146 (cont)	
LM End	16.60	Issue Type +	En	Location *	LS	
Category	Earthen Levee			GPS Latitude/Longitude		
				Start	End	
Item	Encroachments			38.295263 °	38.295263 °	
				-121.566193 °	-121.566193 °	
DWR ID	DWR_RD0003_02_s_2016_146					
Comment Code						
FE : Fence						
Inspector Comment						
Landowner install white fence on landside shoulder. No permit identified for fence.

Looking northeast at new fence on landward slope.

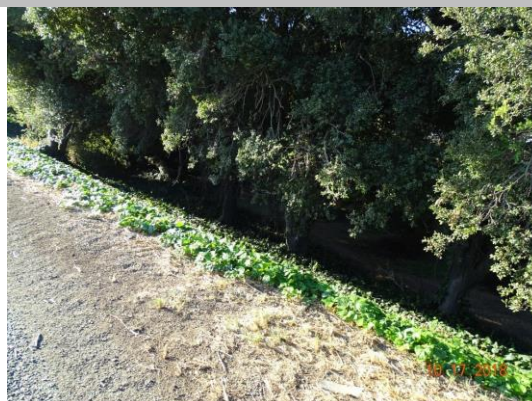
Photo 1 of 1 : FA\_2018\_RD0003\_25\_121\_20181018\_00289.jpg

LM Start	16.62	Rating **	M	Issue No.	121
LM End	16.64	Issue Type +	En	Location *	LS
Category	Earthen Levee			GPS Latitude/Longitude	
				Start	End
Item	Vegetation			38.295578 °	38.295823 °
				-121.566498 °	-121.566717 °
DWR ID	DWR_RD0003_02_f_2018_121				
Comment Code					
V6 : Landscaping					
Inspector Comment					
Remove ivy on landside slope.

View of ivy on land side slope (October 2018).

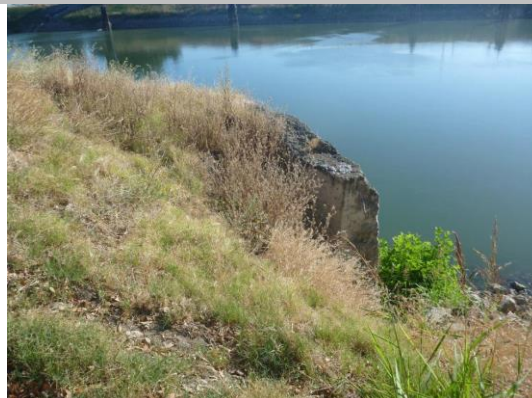
Photo 1 of 3 : FA\_2018\_RD0003\_25\_152\_20180925\_00127.jpg

LM Start	16.90	Rating **	A/W	Issue No.	152
LM End	16.90	Issue Type +	Ma	Location *	
Category	Supplemental			GPS Latitude/Longitude	
				Start	End
Item	2017 Storm Damage			38.298914 °	38.298997 °
				-121.569156 °	-121.569217 °
DWR ID	DWR_RD0003_02_f_2017_152				
Comment Code					
Inspector Comment					
Levee Evaluation Comments					
Description:District station 892+36 to 892+70, Sec. 08, T. 5 N. R. 4 E., M.D.M. Approximately 34 linear feet of erosion exists along the water side slope of the Sacramento River (Unit 2). The erosion commences approximately 1/2 of the way down the slope from the crown and extends into the rip rap. A section of rip rap has eroded away in this location.					
Site ID No:285					
Site Designation:LMA-111					
Repair Type: Erosion					
Rating:Area of Concern					
Field Date:7/28/2017					
Notes: highway on crown

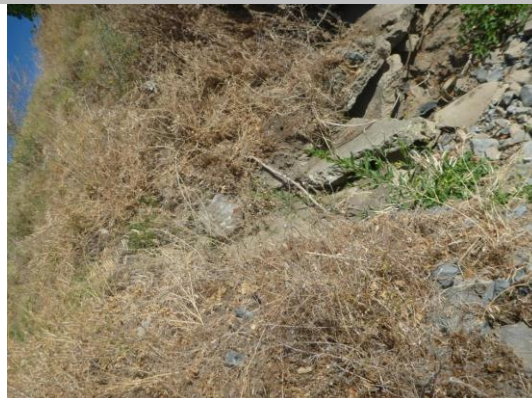
Photo 3 of 3 : FA\_2018\_RD0003\_25\_152\_20180925\_00129.jpg

LM Start	16.90	Rating **	A/W	Issue No.	152 (cont)
LM End	16.90	Issue Type +	Ma	Location *	
Category	Supplemental			GPS Latitude/Longitude	
				Start	End
Item	2017 Storm Damage			38.298914 °	38.298997 °
				-121.569156 °	-121.569217 °
DWR ID	DWR_RD0003_02_f_2017_152				
Comment Code					
Inspector Comment					
Levee Evaluation Comments					
Description:District station 892+36 to 892+70, Sec. 08, T. 5 N. R. 4 E., M.D.M. Approximately 34 linear feet of erosion exists along the water side slope of the Sacramento River (Unit 2). The erosion commences approximately 1/2 of the way down the slope from the crown and extends into the rip rap. A section of rip rap has eroded away in this location.					
Site ID No:285					
Site Designation:LMA-111					
Repair Type: Erosion					
Rating:Area of Concern					
Field Date:7/28/2017					
Notes: highway on crown

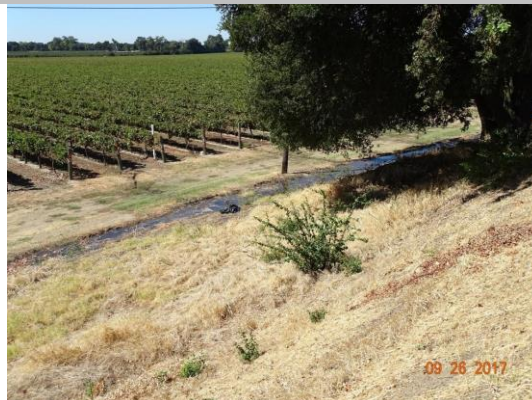
Photo 1 of 1 : FA\_2018\_RD0003\_25\_165\_20180925\_00138.jpg

LM Start	16.97	Rating **	M	Issue No.	165
LM End	16.97	Issue Type +	En	Location *	LS
Category	Earthen Levee			GPS Latitude/Longitude	
				Start	End
Item	Encroachments			38.299744 °	38.299744 °
				-121.570108 °	-121.570108 °
DWR ID	DWR_RD0003_02_f_2017_165				
Comment Code					
DT : Ditch					
Inspector Comment					
Appears landowner has dug a shallow trench along toe of levee to drain water from irrigation.

Looking northwest at the landside slope.

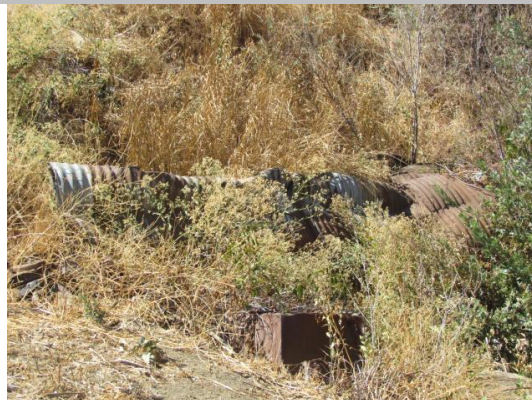
Photo 1 of 1 : FA\_2018\_RD0003\_610\_1\_20180925\_00001.jpg

LM Start	0.02	Rating **	M	Issue No.	1
LM End	0.02	Issue Type +	En	Location *	WS
Category	Earthen Levee			GPS Latitude/Longitude	
				Start	End
Item	Encroachments			38.182059 °	38.182059 °
				-121.653608 °	-121.653608 °
DWR ID	DWR_RD0003_03_f_2015_1				
Comment Code					
GA : Garbage					
Inspector Comment					
Discarded pipe on waterward slope.

Looking at discarded pipe on waterward slope.

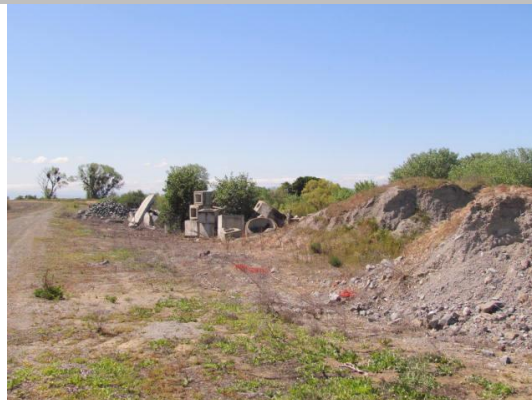
Photo 1 of 1 : FA\_2018\_RD0003\_610\_6\_20180925\_00003.jpg

LM Start	0.25	Rating **	M	Issue No.	6
LM End	0.29	Issue Type +	En	Location *	WS
Category	Earthen Levee			GPS Latitude/Longitude	
				Start	End
Item	Encroachments			38.178635 °	38.178037 °
				-121.653695 °	-121.653715 °
DWR ID	DWR_RD0003_03_s_2013_6				
Comment Code					
MA : Material					
Inspector Comment					
Stockpile of concrete rubble and sandpile on waterward slope for immediate access to some flood fight materials.

Looking east at concrete rubble and other material stored on landward shoulder and slope.
